**TRINITY LUTHERAN CHURCH****CHURCH COUNCIL MINUTES**

**Appendix**  
**Trinity Drainage Report**  
**Stephen Boss, Thomas Edgar**  
**9-12-2022**

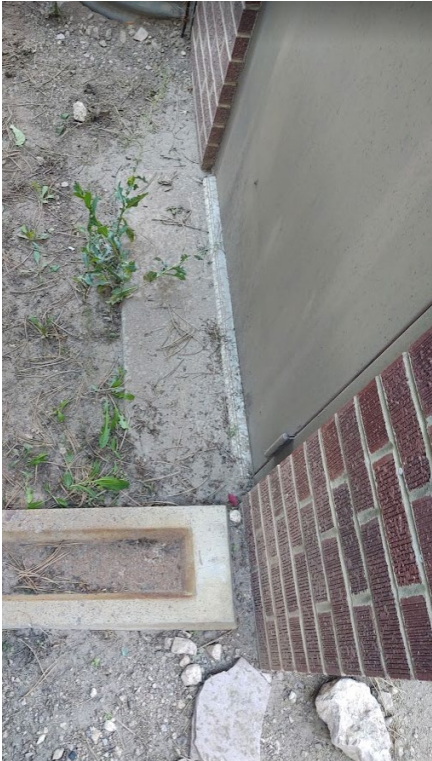
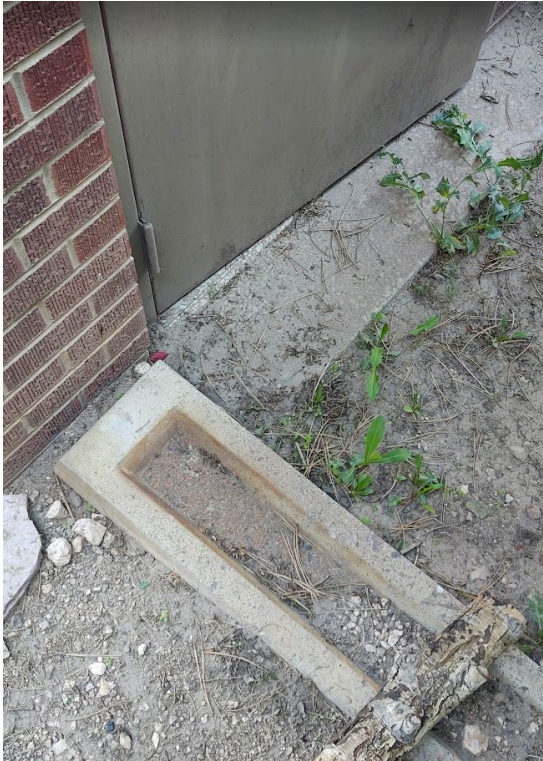
**South Door Threshold** – Currently the threshold on the south doors has failed. One can see light under the door. This opening does not prevent water from entering the building, especially since the area around he door is a low point and water pools there. Thom thought fixing this might be

an easy and inexpensive fix. He will investigate obtaining materials. We will coordinate efforts on this project.

**Window Well** – Install a window well (that will still allow for fire escape egress) around the south door. We will fill in the low spot, trench, get a new threshold installed and surround the door with a window well, out water entry problem should be motely eliminated.

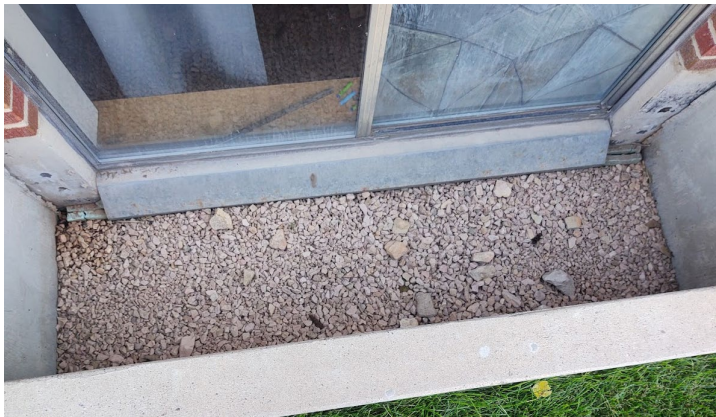
**Campus Cabinet Window Well** – Assess the depth of the rock aggregate in the well. Dig down further (up to 4') if necessary and place more aggregate in the void.

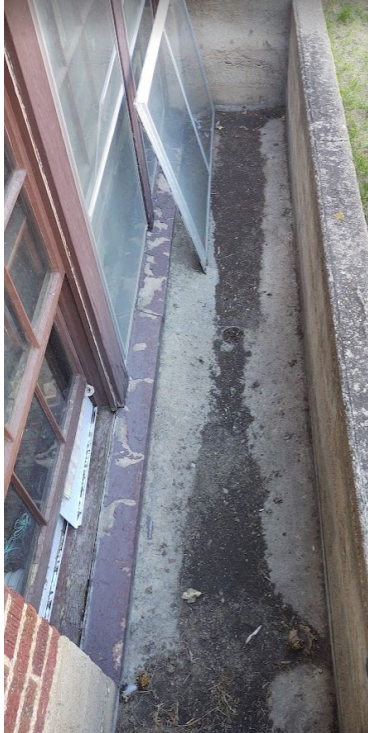
**Center Window Well - Remove French Drain/Concrete Floor** – Currently the floor of the center windows well is cemented with a French drain. We propose demoing out the cement, digging down about 4' then filling the void with rock aggregate.

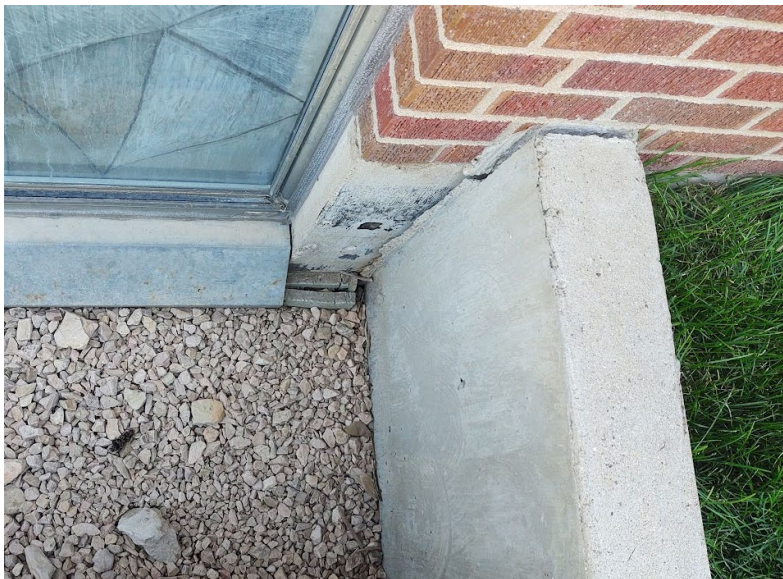
**Grout** – Grout the seams (left and right) of the window wells on the west side of the church as the cement has pulled away from the foundation leaving a void for water to flow in from the grassy impoundment that can get overwhelmed by the volume of water coming off the roof.

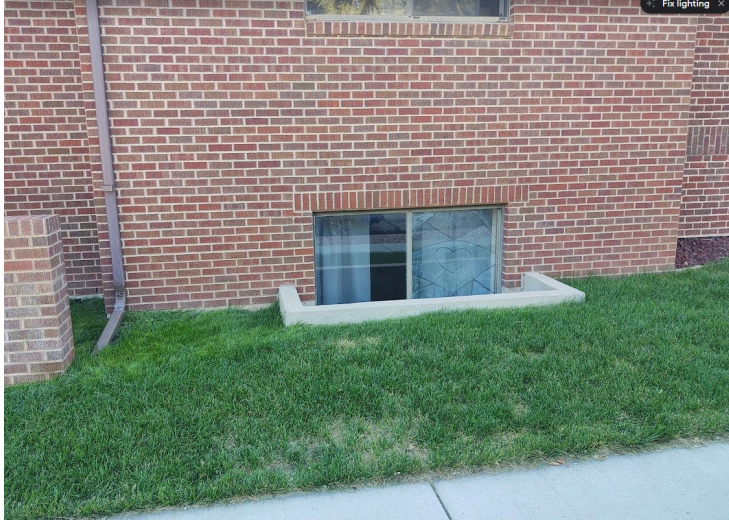
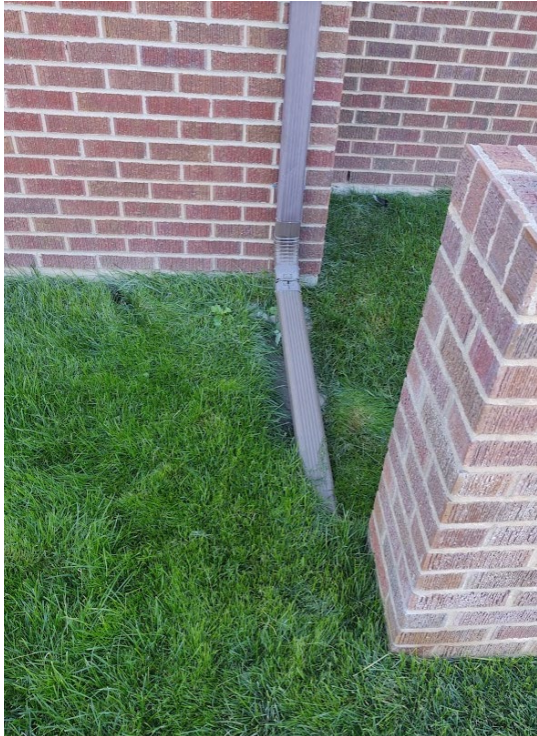
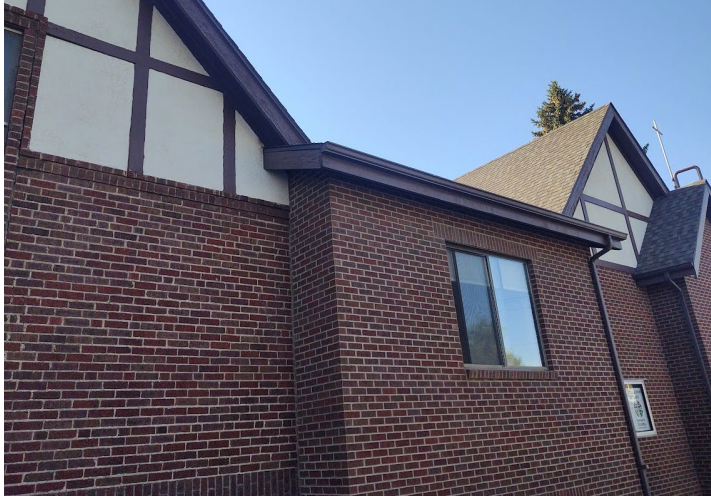
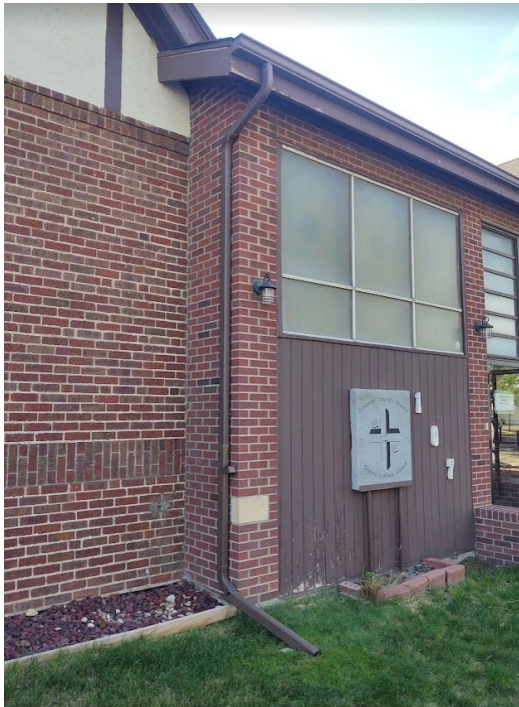
**Roof Drainage/Gutters/Downspouts** – I plan to have ABC Seamless assess the roof drainage on the West side of the building as these infrastructure appeared to be overwhelmed by the volume of rain from the storm. I also feel that the downspouts are too short and the water pools on the grass to the east of the sidewalks and easily enters the building via the window wells.
